## OVER EIGHT DECADES OLD “YOUNG” LANDSLIDE – A CASE STUDY

### ABSTRACT

Shirobagad also named as Kaliasaur Landslide was developed in the year 1920 at kilometer-147 on National Highway – 58 (earlier named as State Highway - 45) at latitude 30° 14' 30" N and longitude 78° 53' 57" in Garhwal region of western Himalaya. This landslide has been investigated by a number of organizations in India and a wealth of data has been generated mainly on geological aspects. Central Road Research Institute has also investigated this landslide during 2007-2011 covering geological as well as geotechnical aspects. The study area basically encompasses metavolcanics and variants of quartzite rock (e.g. pink and white quartzite) with occasional bands of shale. Frequent presence of displacement along structural planes, offsetting of beds, omission and re-appearance of the strata, and change in the attitude of structural planes illustrates the presence of a series of minor faults, it includes contact between litho units drainages etc. Having observed these geological features and many more others the study has further included micro analysis and observations based on Rock mass rating and Slope mass rati

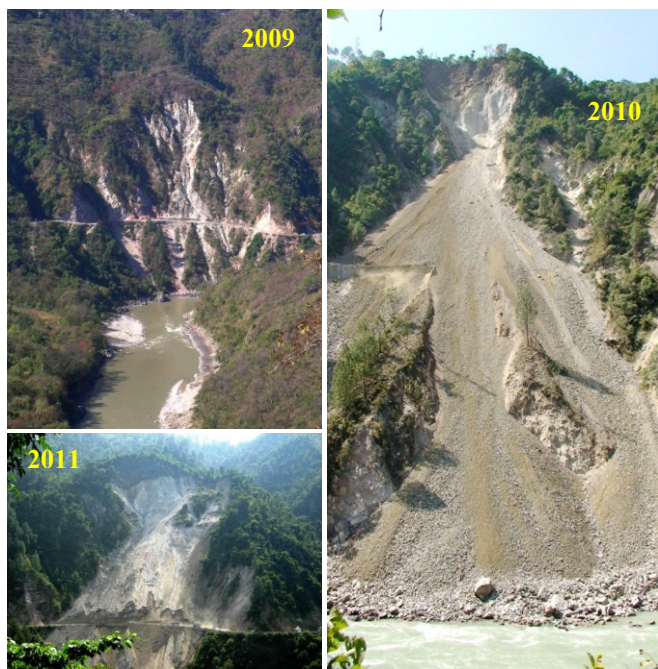
Fig. 2. Metamorphosis of Kaliasaur Landslide Year by Year

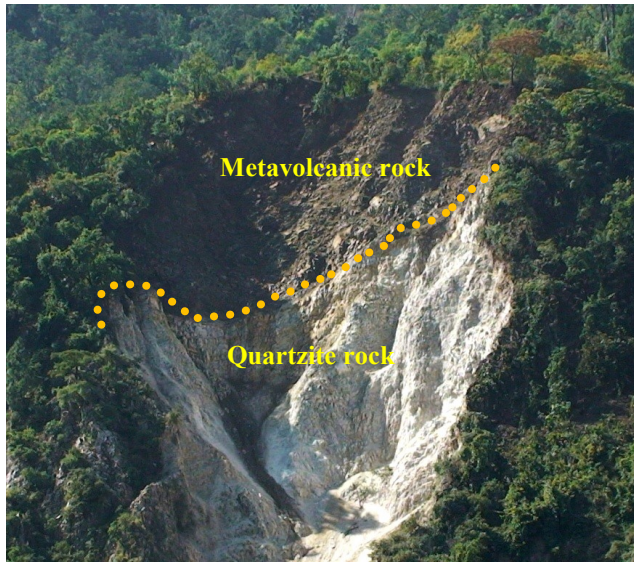
scar below the crown has distinct contact between highly fractures quartzite and highly weathered metavolcanic rocks which are vulnerable to further failure in coming monsoon (Fig 5).

Fig. 5. Contact between Metavolcanic and Quartzite Rocks

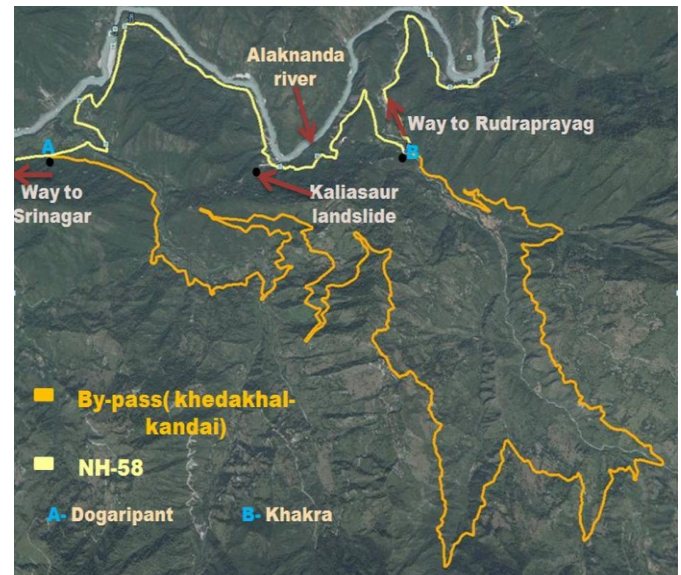
Fig. 13. View of Kaliasaur Area Depicts by-pass from Dogaripant to Khakra

When a road is closed, travelers mostly followed the detours that take longer travel distance to reach the destination. Costs of outages can be estimated by the impact of the detour on travelers. The closure of NH-58 at Kaliasaur slide, forced the travelers to detour through by-pass: Khedakhal- Kandai having distance around 28km (Fig 13). To calculate the cost of this detour, we examined traffic pattern along the highway and estimated the average daily traffic (ADT). By putting the required values of parameters mention in above equation, the total detouring cost for 45 days (approx.) during September-October, 2010 was Rs 2, 45, 43,180 or 25 million Indian currencies. This indirect cost of detour is still a low estimate as it does not include other business ramifications from loss of access to local resources and an associated loss of business at local shops, restaurants, tourist sites, and hotels. This example
